Subject: Environmental Assessment Proposal

**Laytonville Rancheria  
Cahto Tribe**

**ENVIRONMENTAL ASSESSMENT  
SCOPE OF WORK**

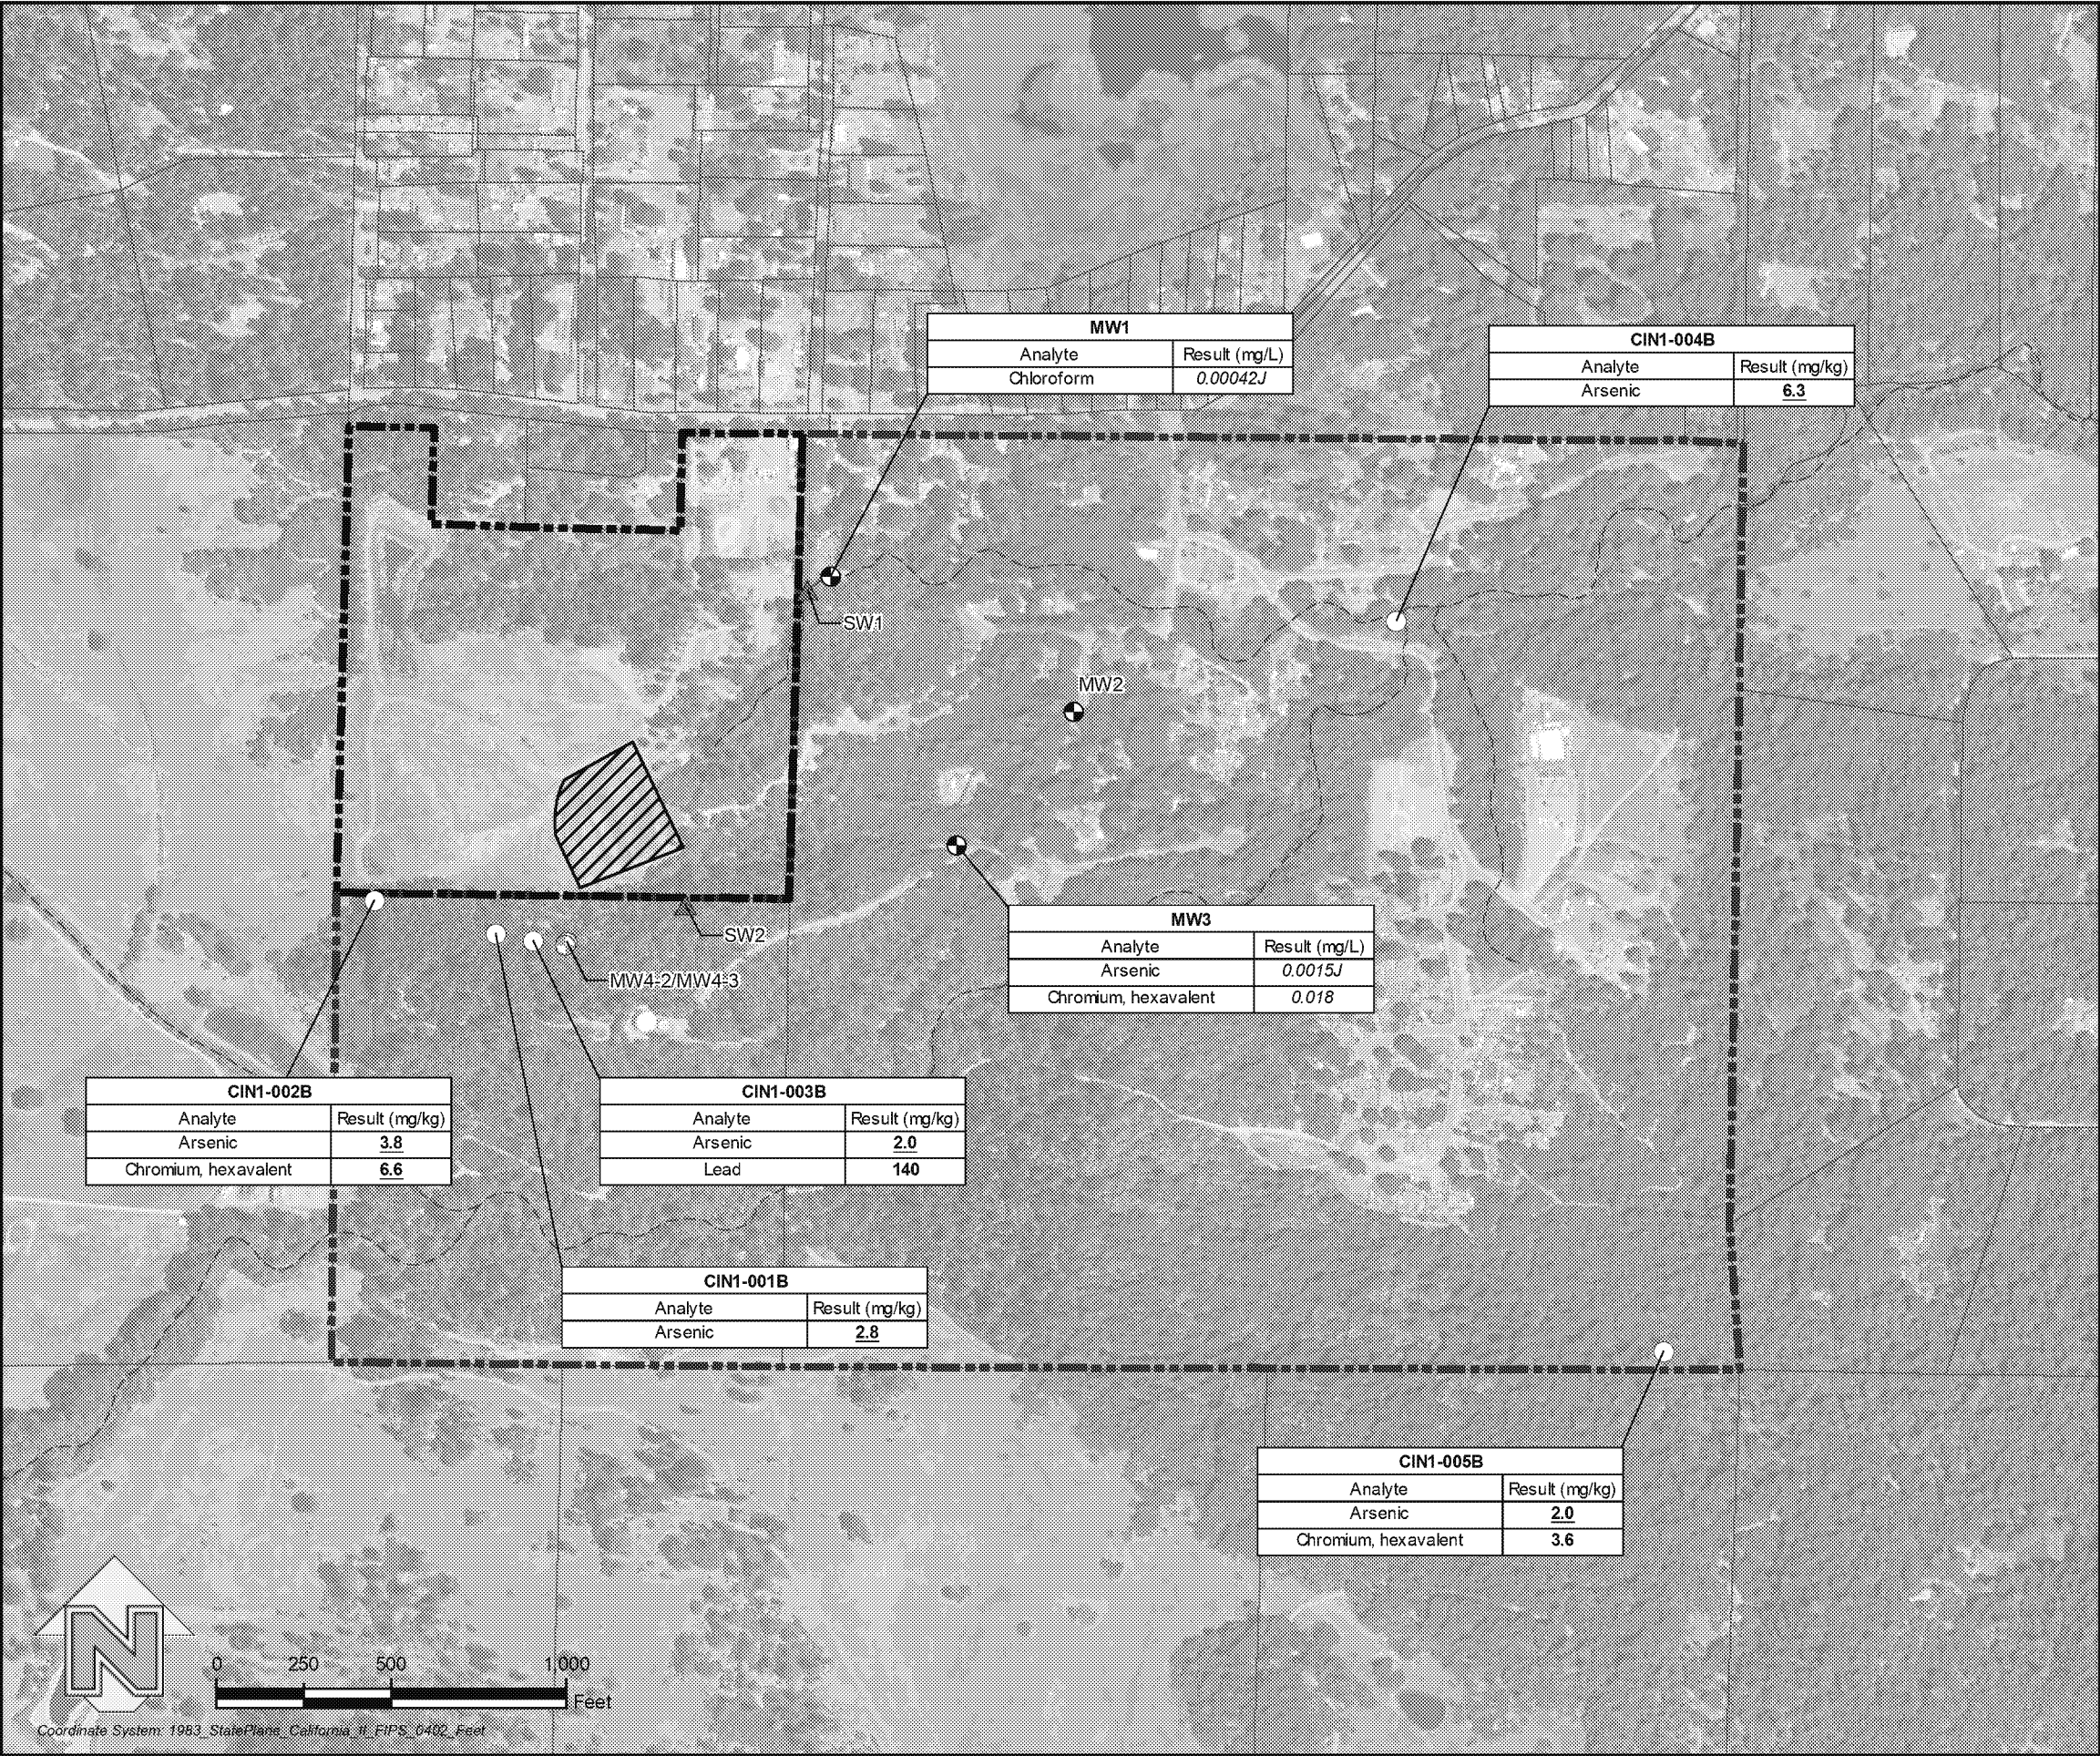
Drafter	Date	Figure No.
J.D.C.	12/09/2016	2

In October 2016, AFSI collected soil samples from the same locations as the Cahto samples (See Figure 2) and analyzed them for metals, including (mercury and hexavalent chromium) and PCBs. Samples CIN1-001B and CIN1-004B were also analyzed for organochlorine pesticides and dioxins/furans because of the presence of stressed vegetation. Arsenic was detected in concentrations greater than both residential and commercial RBSLs in all the samples, including CIN1-005B, which is considered a background sample (See Figure 2). The concentration of lead was greater than the residential RBSL in CIN1-003B. The concentration of hexavalent chromium was greater than residential and commercial RBSLs in CIN1-002B and greater than the residential RBSL in CIN1-005B. Summarized results of detected analytes in soil samples are provided in Table 1. All results including analyte detection limits and qualified data are provided in Appendix A.

In November, AFSI collected groundwater samples from the three existing monitoring wells on the Rancheria and two surface water samples at the boundary of the Mendocino landfill property (See Figure 2). Surface water sample SW1 was collected along the eastern boundary of the Mendocino County property from a flowing stream emanating from near the capped landfill cell. SW2 was collected from a seep observed south of the capped landfill cell and downslope of it. The seep did not have adequate water flow to collect the volume of water necessary to perform all the analyses. This sample, SW2 was only analyzed for VOCs, Title 22 metals, mercury, and hexavalent chromium. The three groundwater samples and surface water sample SW1 were analyzed for Title 22 metals, mercury, hexavalent chromium, VOCs including MTBE, SVOCs, organochlorine pesticides, herbicides, PCBs, and dioxins and furans. Hexavalent chromium, arsenic and chloroform were detected in individual monitoring wells (Table 2). No other contaminants of potential concern (COPCs) were detected above the Maximum Contaminants Levels (MCLs) or the RBSLs for human health. Complete groundwater and surface water data are provided in Appendix A.
